BUSINESS PAPER

Infrastructure and Environment
Committee Meeting

Council Chambers
17 March 2025

SUBJECT: DEVELOPMENT APPLICATION 108/2024 - SUBDIVISION OF LAND OF 1 LOT TO 15 LOTS AND ASSOCIATED EARTHWORKS AND UTILITY SERVICE INSTALLATION - 1 HYNES STREET, BROKEN HILL D25/10203

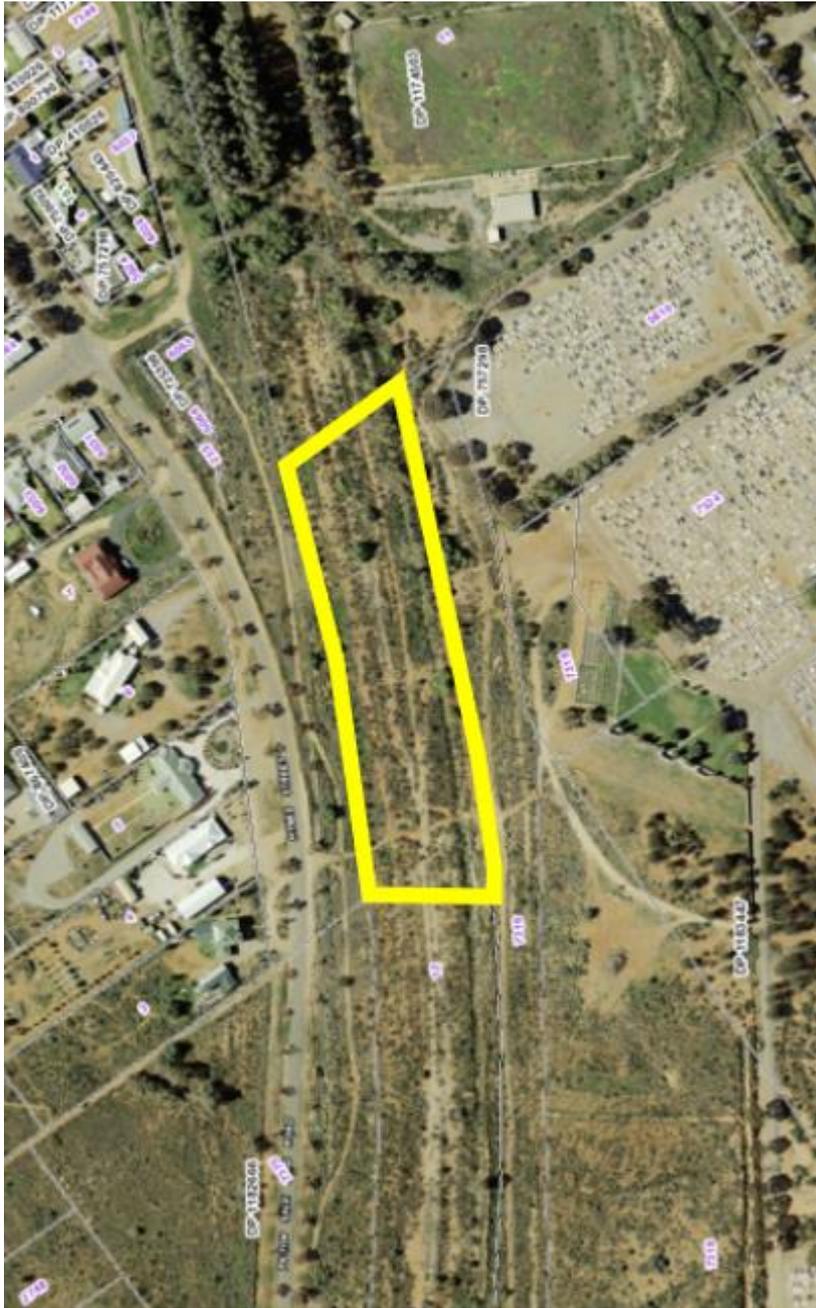
SITE LOCATION (Portion of land which is primary focus of this subdivision proposal):

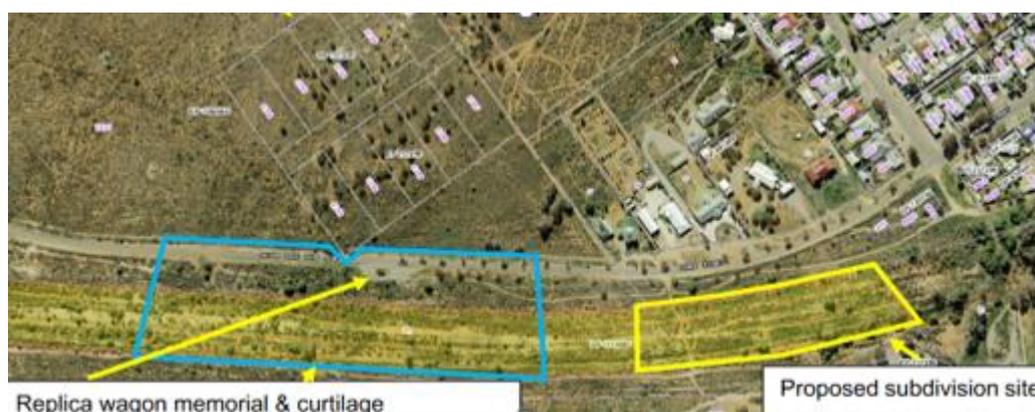
Heritage item SHR 02002, 1915 Picnic Train Attack Site, “is marked by a memorial consisting of a replica freight wagon placed on the southern side of Picton Sales Yard Road, Broken Hill. The embankment of the Tramway Permanent Way lies about 50m north (sic) of the memorial. In between is the trench of the water pipeline from Umberumberka Reservoir”

In a general sense, the Heritage item boundary is within the central portion of the subject site.

The heritage item is currently adjoined by residential development which is within as close a proximity than that resulting by the proposed development. It is not considered any impact to the heritage item will result from the proposed development.

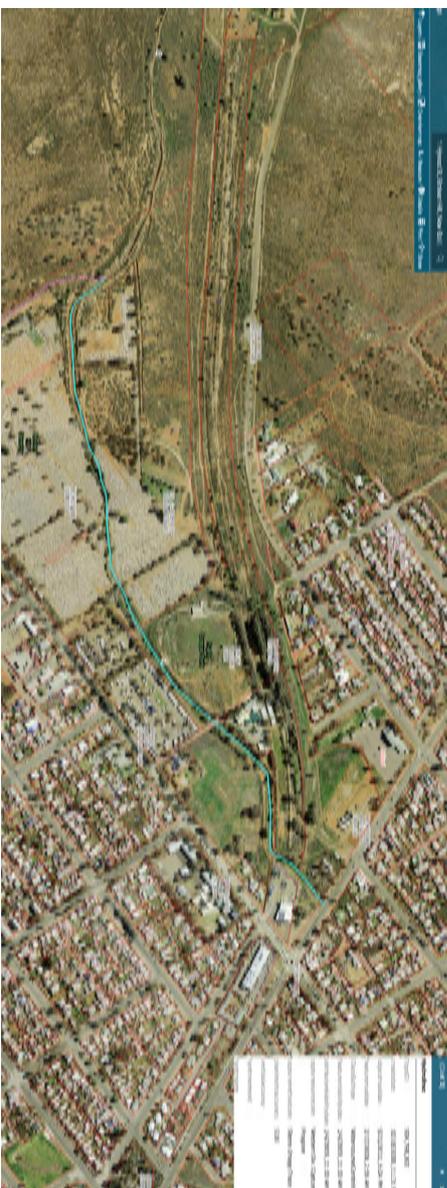
<p>2.1.11 Environmental constraints, natural site features, vegetation, topography & other key site considerations</p>	<ul style="list-style-type: none"> • The site is mostly devoid of any significant vegetation. In its current state, it is unlikely the site would contain significant flora or fauna species. There is no mapped biodiversity of high value. • An unnamed, minor, non-perennial and non-mapped natural overland watercourse toward the rear of the site. • Bushfire prone land category 3 • Generally flat land with gentle downward slope of approximately 1% from north east to south west across the site with a height difference of approximately 2m over 230m with site elevation between 300-302AHD. In the site area subject to the proposed development. A sudden decrease of elevation (approximately 1m) to the back of the block is present due to a possible formed river with gentle downward slope (draining) from east to west. However, this is not identified on hydrospatial mapping per below image. • Review of WaterNSW Real-time Water Database indicated no groundwater bores within 1km of the site. Temporary or stagnant groundwater may be encountered within the soil profile at times of and following heavy or extended rainfall. No springs were listed within 1km of the site in the NSW Government Hydrography Spatial Data (SEED, 2019). • Multiple land zoning of R1 and C4 • Image: NSW Hydrography map for the site. Showing nmo m,apped watercourses within the site. • Image: Site survey and proposed plan of subdivision

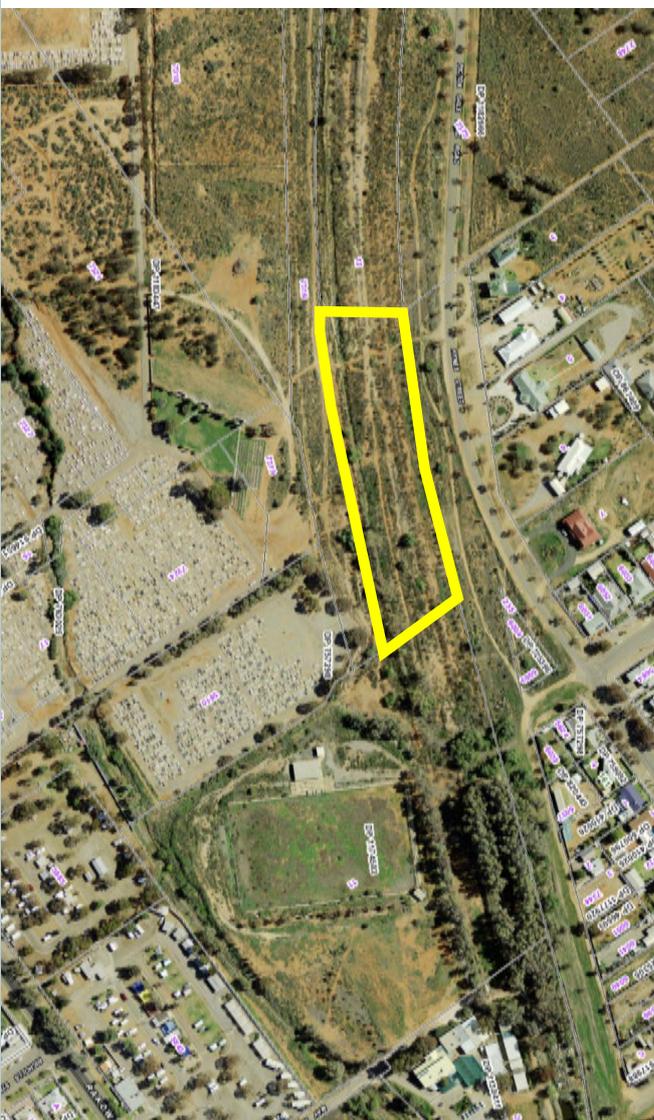
<p>2.2 Surrounding development & land zoning</p>	<ul style="list-style-type: none"> • The area of the site subject to the proposed development is predominantly adjoined by R1 General residential zoned land to the north east and south. Land to immediate north contains large lot residential development with land to the north east containing smaller lot residential development. • A rugby league ground adjoins the eastern site boundary. • A vacant lot adjoins the southern site boundary with the Broken Hill cemetery located beyond. Which is a listed local heritage No. 140. item • The site is also adjoined by vacant land of C2 and RU2 land zoning to the north and east in the area of the site not subject to the proposed development.

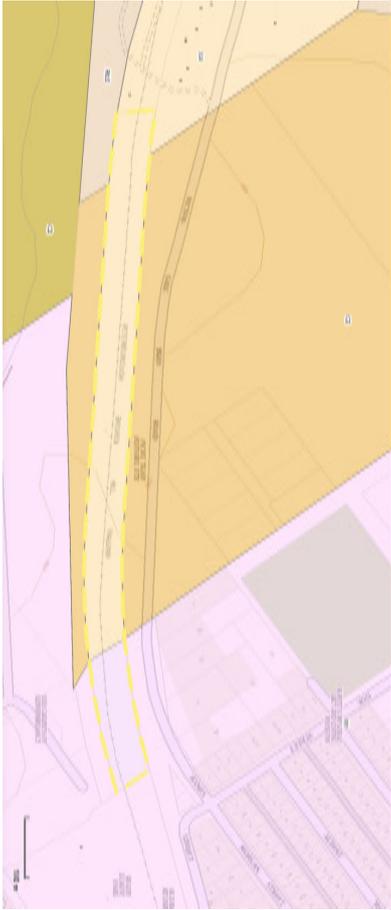
Applicable LEP	Broken Hill Local Environmental Plan 2013
LEP clause	Comment
Land zoning	The site contains dual R1 General Residential and C4 Environmental Living zoning.

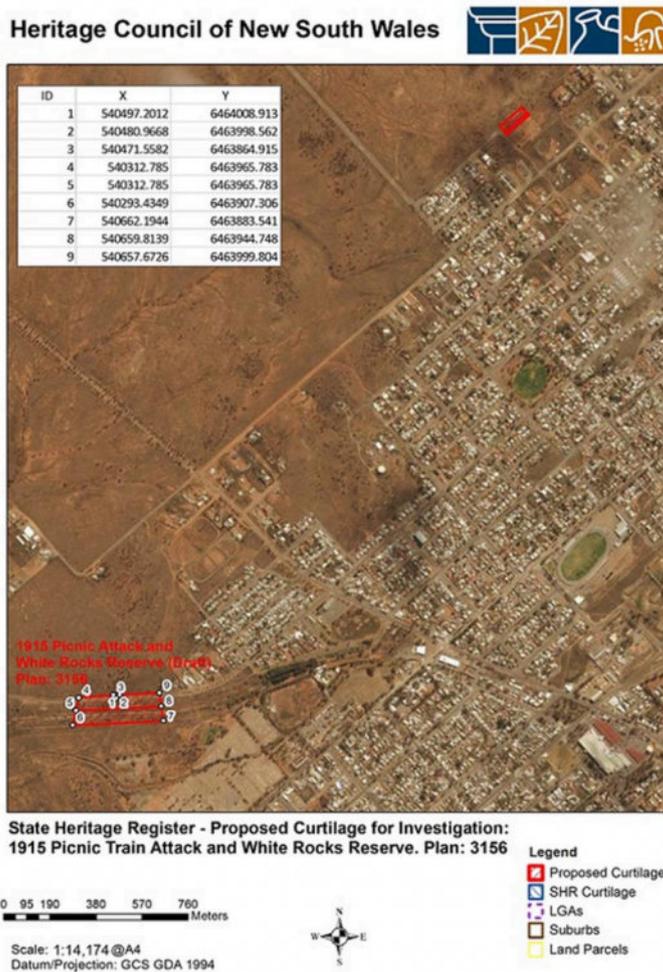
Figure 4: SHR 02002 curtilage investigation area⁷

1915 Picnic Train Attack & White Rocks Reserve⁷ at Hynes Street & Schlapp Streets, Broken Hill
Listing Boundary Endorsed

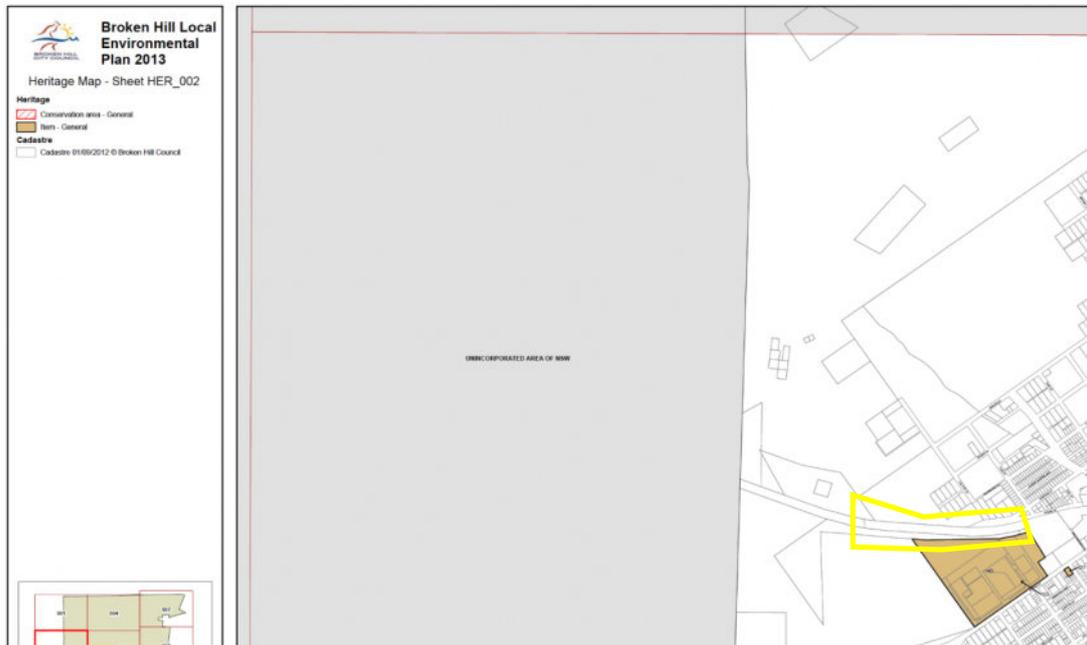
Figure 13: BHLEP 2013 Heritage Map Sheet HER_002

Figure 13, Figure 14, and Figure 15 identify the location of local heritage item I40, cemetery and existing development in the vicinity of the proposed development site.

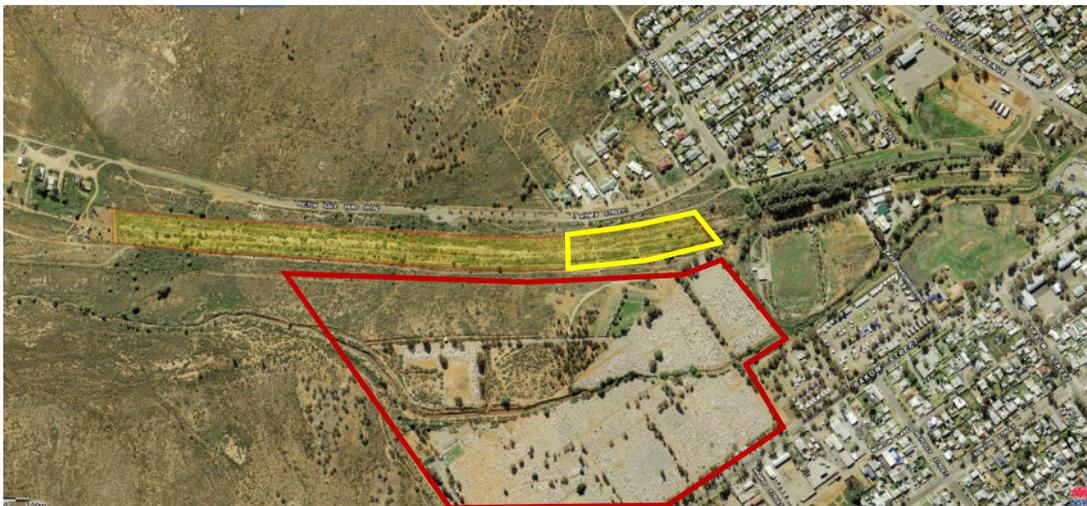
Figure 14: Overview aerial image of site in relation to local heritage item I40, cemetery¹³

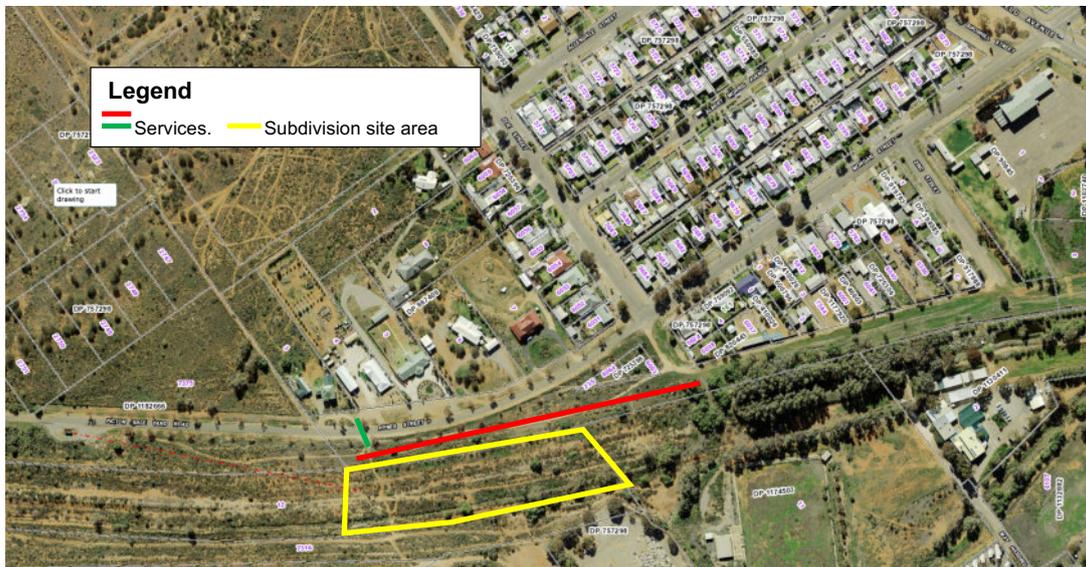
Figure 17: Location of water, sewer, electrical and telecommunication services to be extended along Hynes Street aerial image overlay

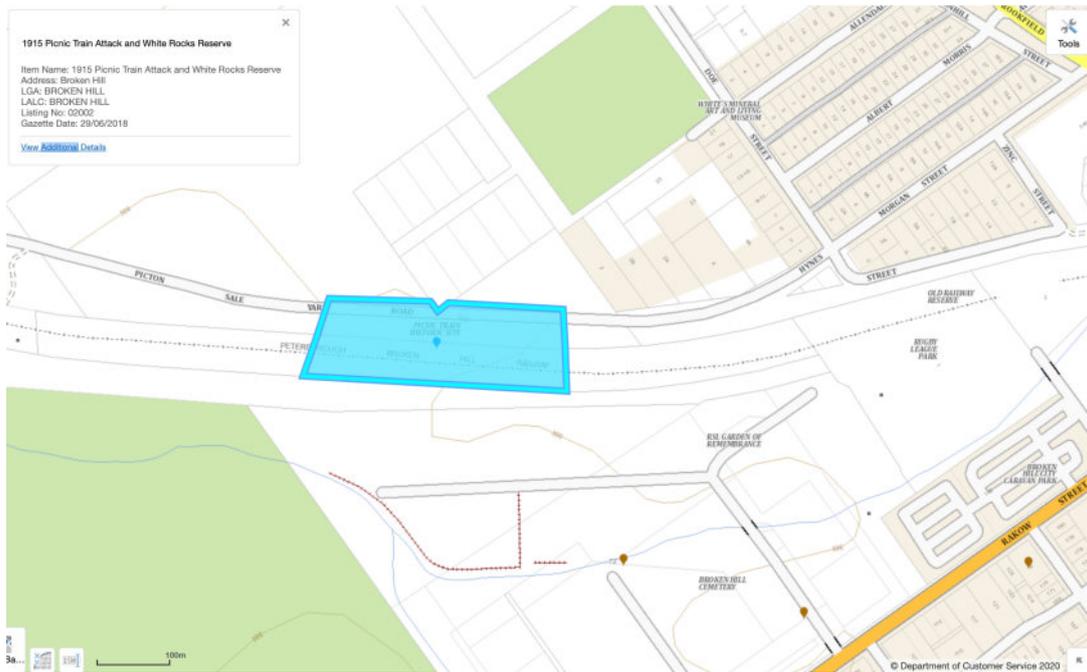
Figure 22: SHR 02002 NSW Heritage Inventory Listing – map site and curtilage – street map overlay

The following images identify SHR 02002 and curtilage relative the proposed development site and surrounding area.

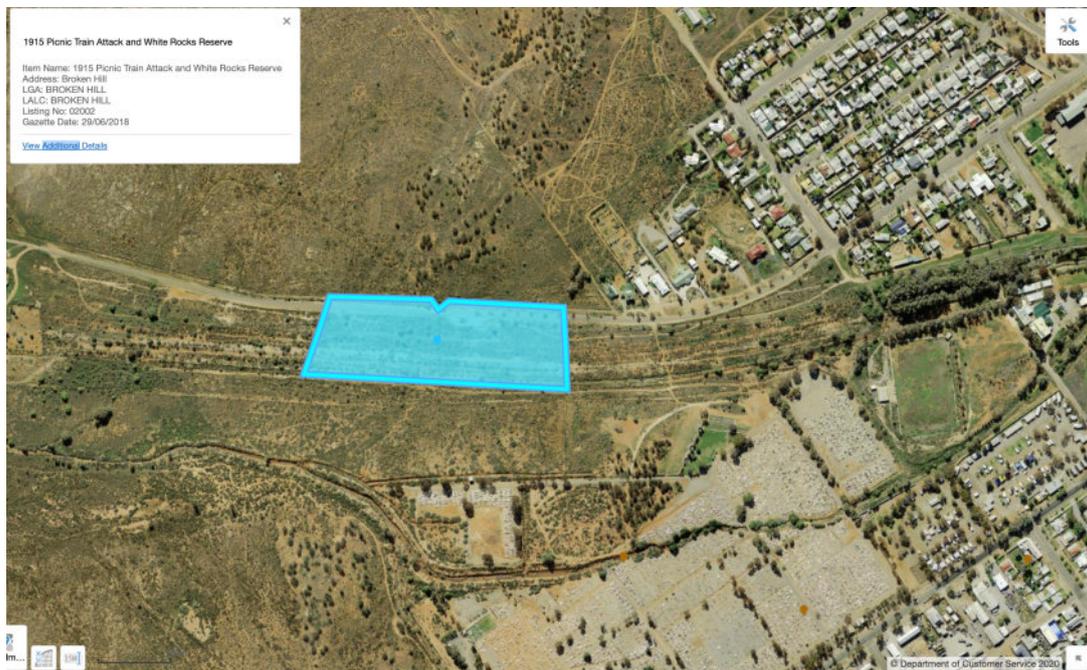
Figure 23: SHR 02002 NSW Heritage Inventory Listing – map site and curtilage – aerial image overlay

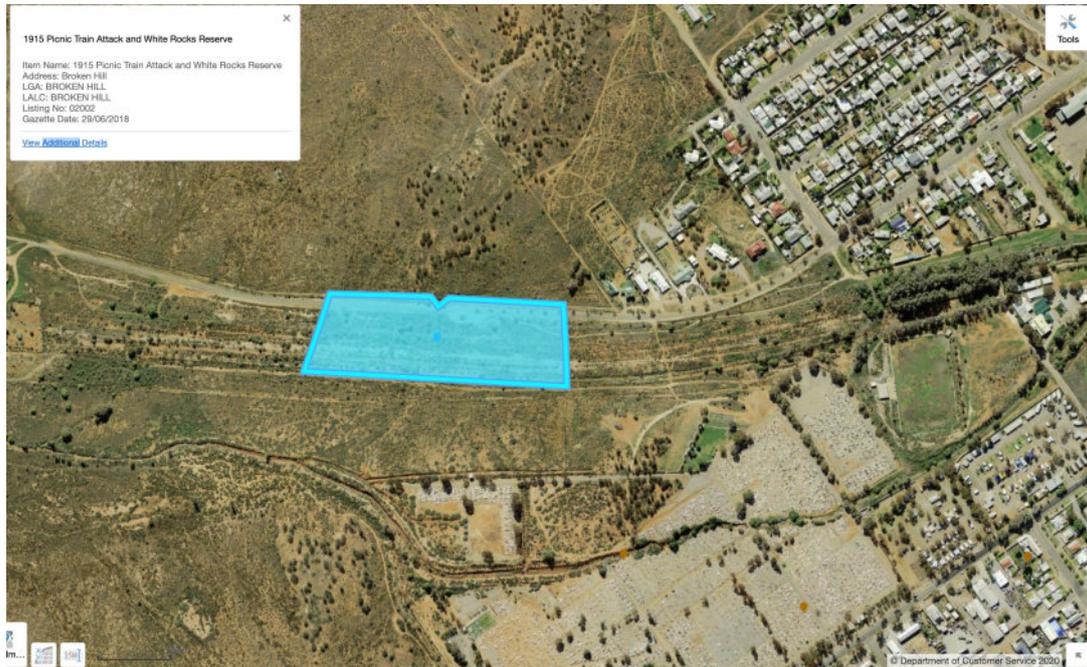
Figure 29: SHR 02002 heritage curtilage relative to site

The proposed development seeks a much lower yield than permissible, proposing fourteen residential lots located within the R1 zoned portion of the site of between 900m² and 1,400m², with the residual lot containing the heritage curtilage untouched. The development as proposed provides lot areas that are commensurate with the residential subdivision pattern within the immediate vicinity of the site and heritage

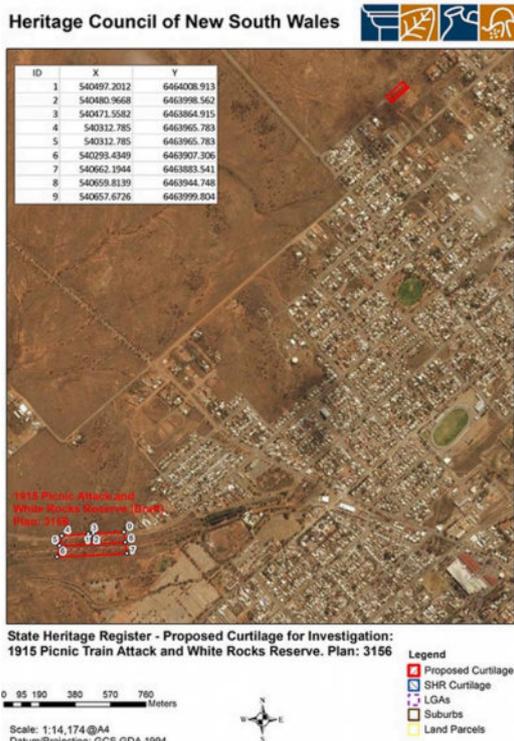
Figure 35: Aerial image development pattern at time of heritage listing of SHR 02002 1915 Picnic Train Attack site

1915 Picnic Train Attack & White Rocks Reserve" at Hynes Street & Schlapp Streets, Broken Hill
Listing Boundary Endorsed

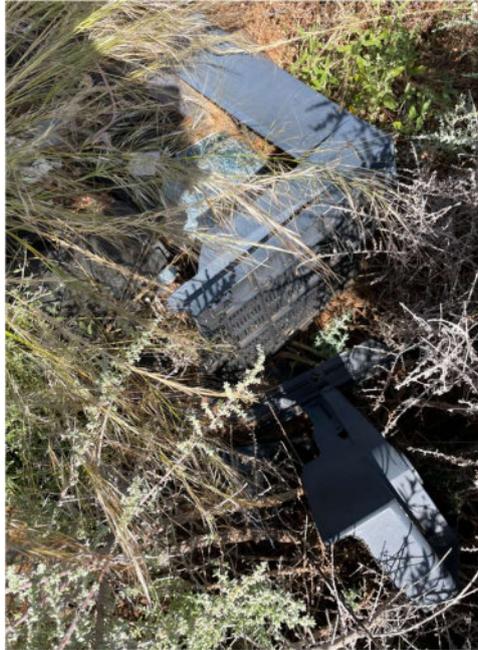
Computer

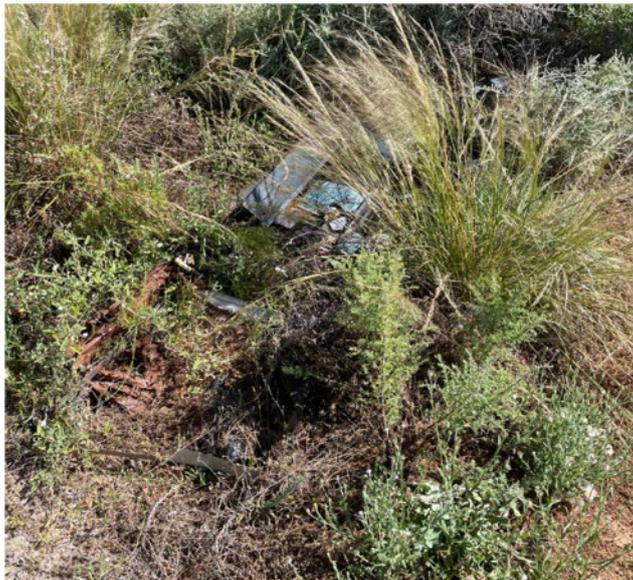
Sheet Metal and Broken Glass

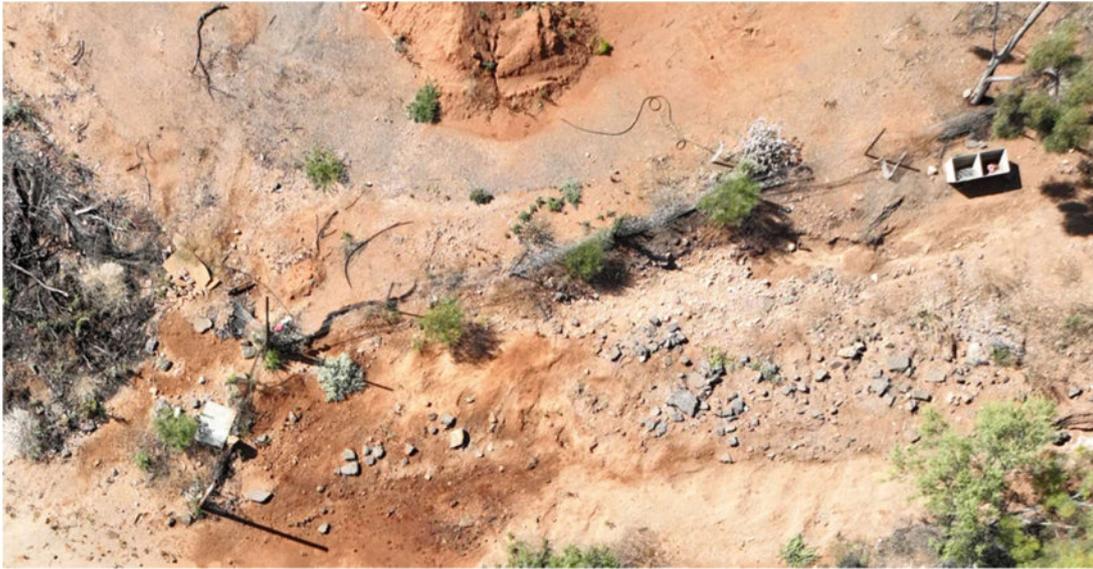
Some Construction waste, mostly Concrete
(may fall outside of property)
